**INTERSTATE 29 NORTHBOUND  
BRIDGE over the  
PERRY CREEK CONDUIT**

**SIOUX CITY, IOWA**

**FIRE DAMAGE INSPECTION  
REPORT**

**NOVEMBER 2, 2019**

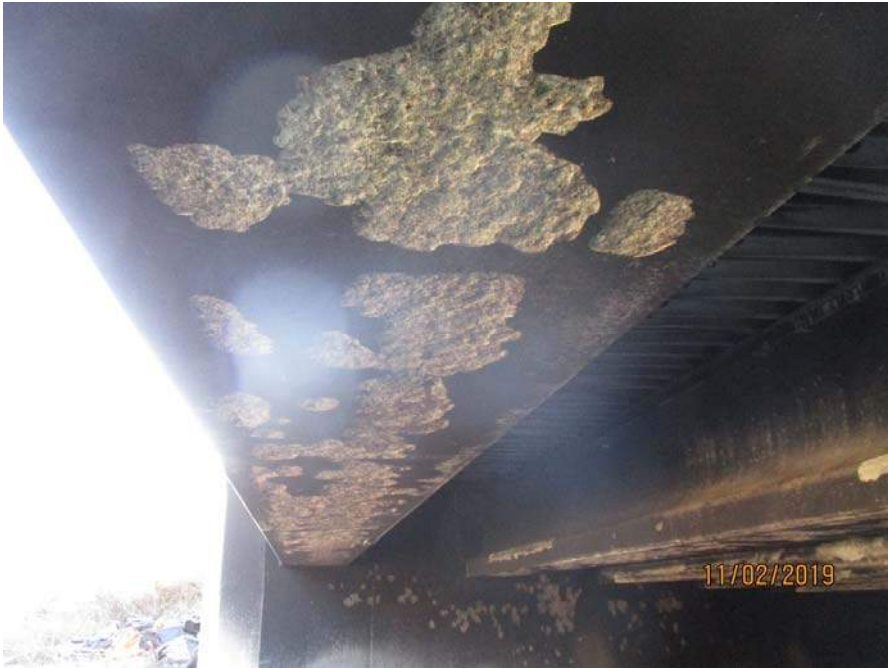
GIRDER "H" –BOTTOM FLANGE MINOR  
SPALLING

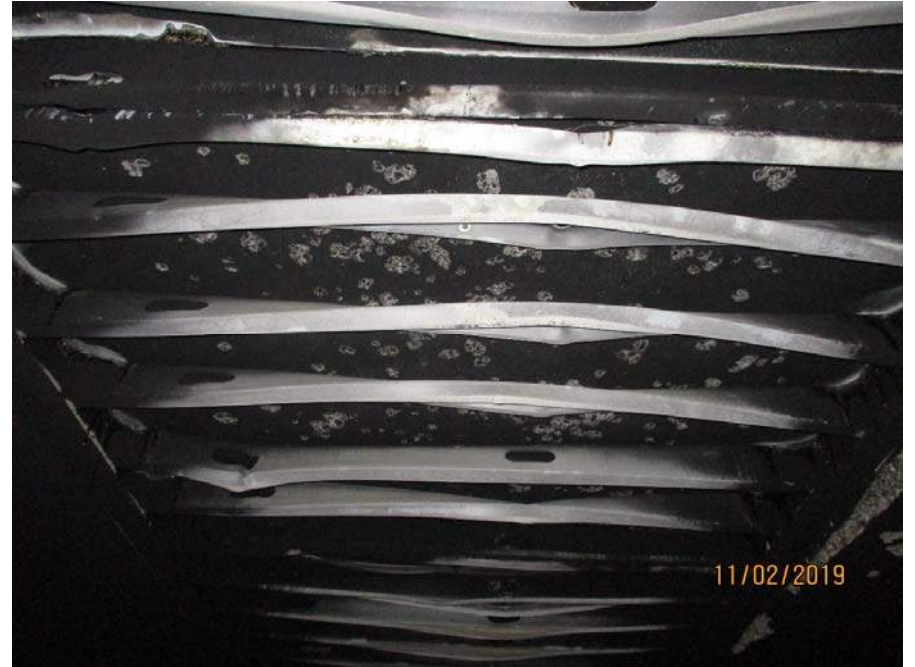
TYPICAL BOTTOM OF DECK SPALLING
